# Atlas 210X/215X Transceivers Engineering Supplement

Includes the LE Model

Version 3.71  
January 28, 2019

Written By:  
Kevin Murphy – ZL1UJG  
Clint Chron – W7KEC

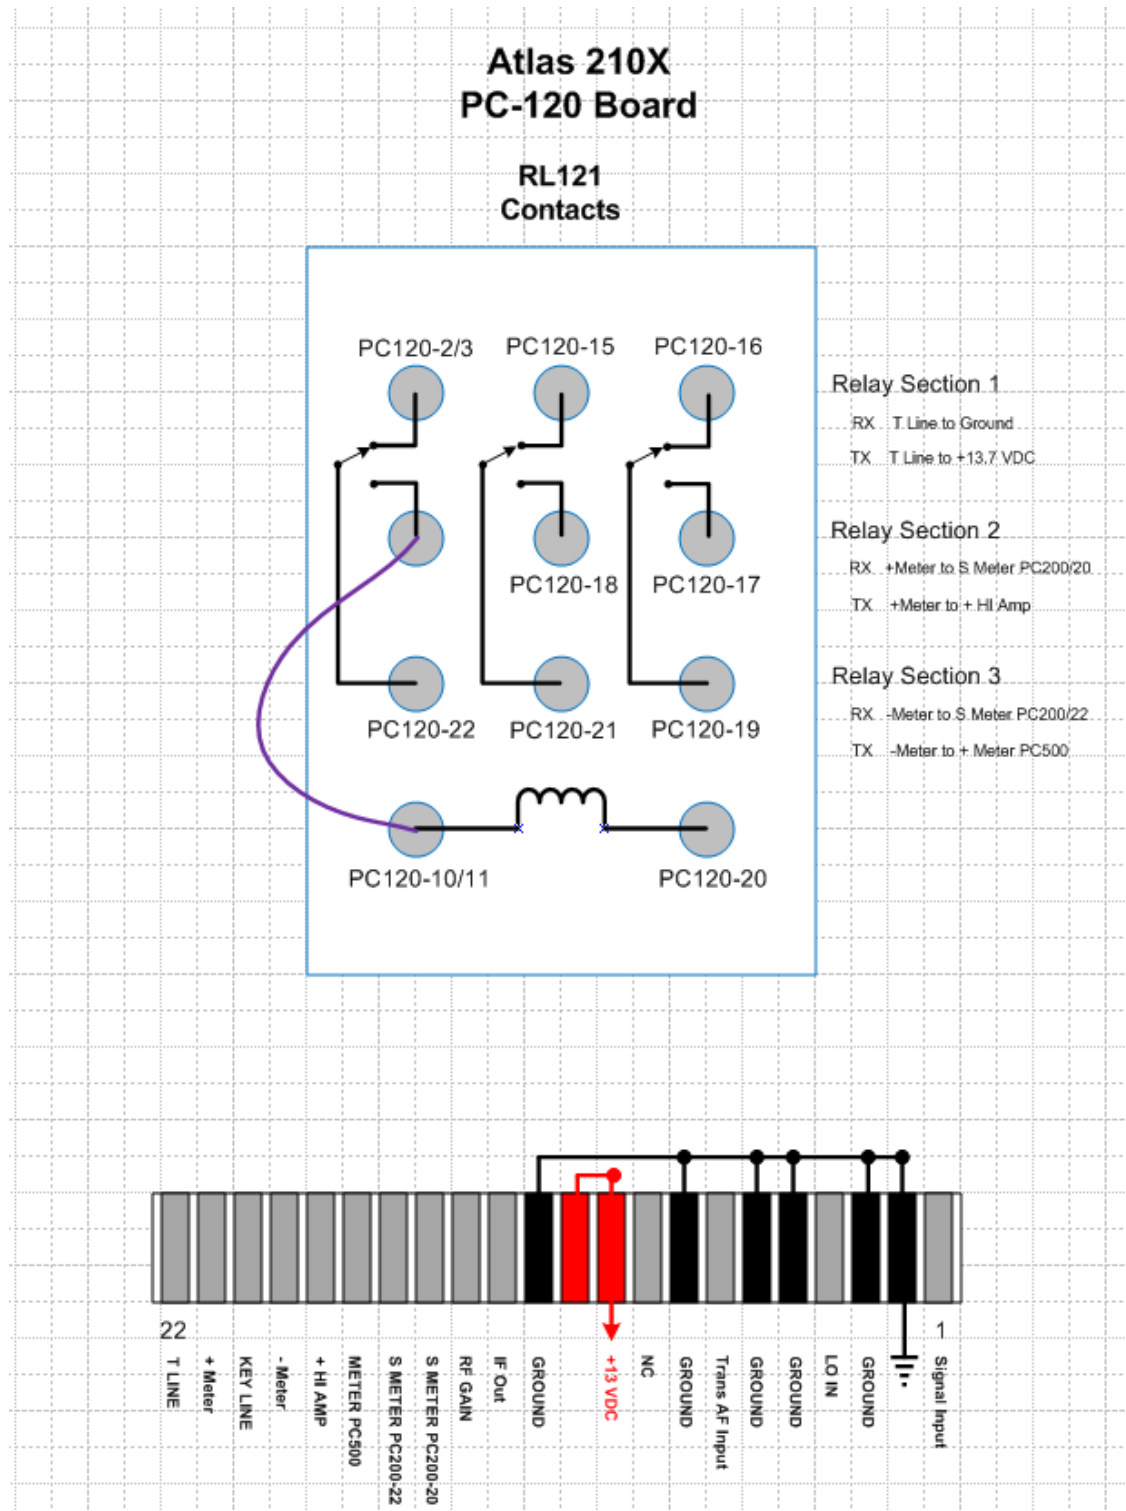
The DC Switching Relay is located on the PC-100/PC-120 board,

It is very easy to remove the plastic cover on the DC Switching relay. The PC-100/PC-120 board should be removed from the radio before attempting to remove the cover. Once the cover is removed, burnish all relay contacts. A few ohms of resistance on the TX meter contacts can cause the meter to be totally inoperative in the TX mode (meter would be showing TX current).

The following diagram can be helpful in trouble-shooting the switch contacts of this relay:

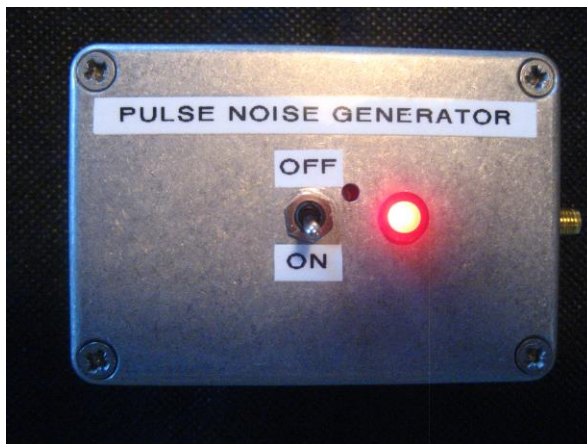
Here are some pictures of the completed unit:

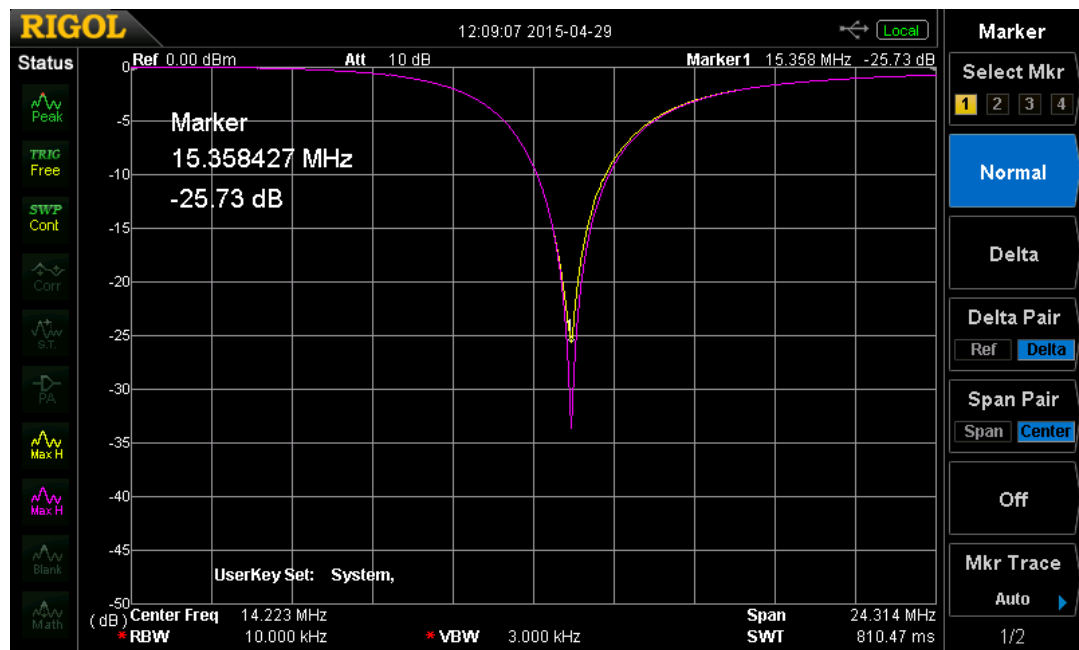
Here is a spectrum analyzer sweep that shows the difference between a 240 pf X5F capacitor and a 220 pf silver mica capacitor when used in a simple parallel trap circuit. The trace for the 220 pf silver mica capacitor is shown in purple.

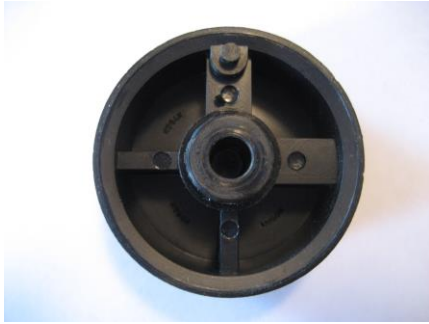
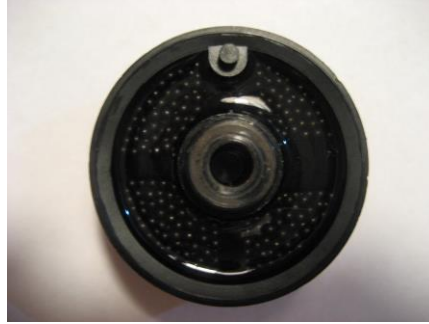
This knob is easier to upgrade because you do not have to worry about resin running into the hub set screw opening. The weight of the knob goes from 25 grams to 75 grams.

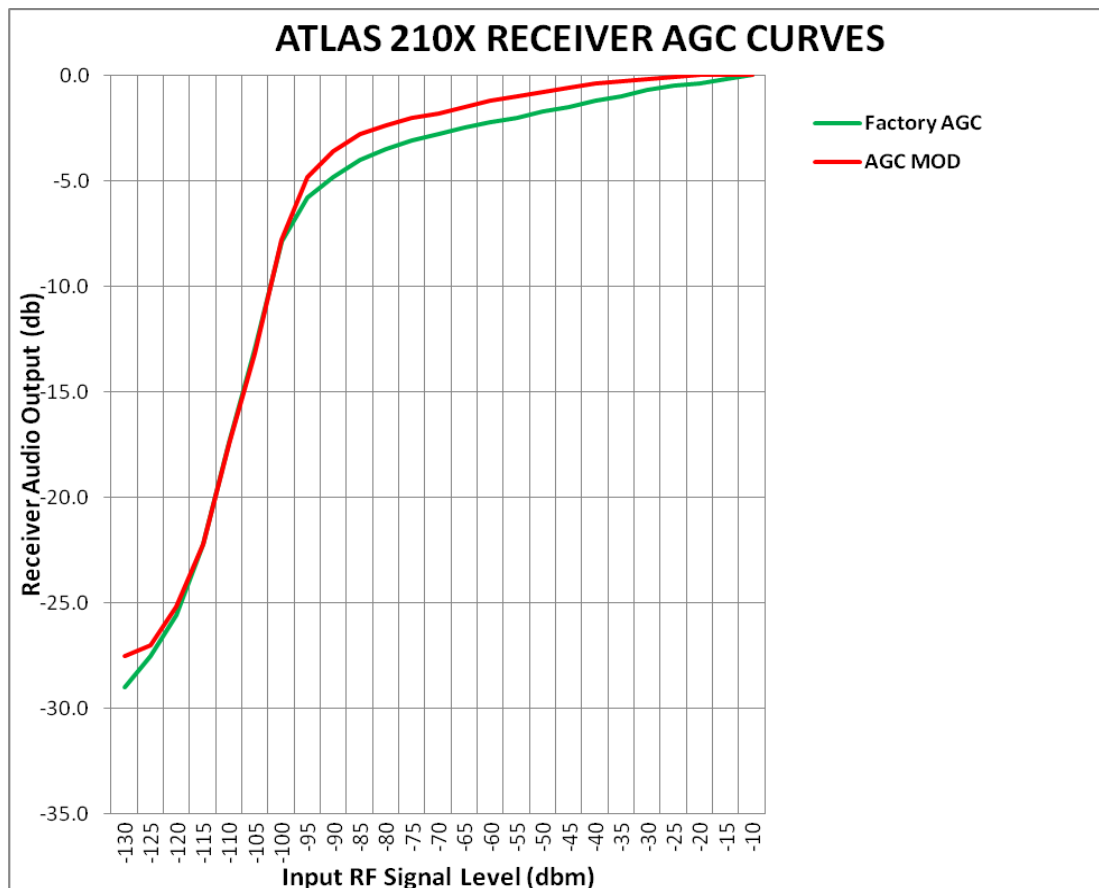
Here is a plot of the AGC curves for a standard radio and one that has the AGC mod installed.

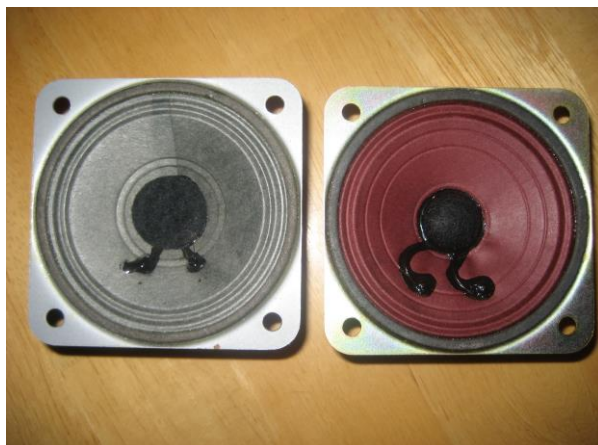
This speaker has large magnet so it provides more audio out. The back of the magnet will hit the circuit board side variable capacitor on the PC-200 board, but that does not seem to cause any issues. Here is a picture of the stock Atlas speaker and the KWM380 unit. The speaker on the right is the KWM380 unit.

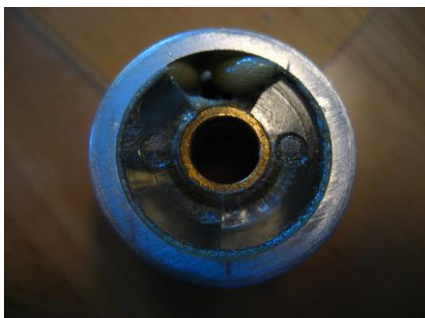
View of aluminum collar around the plastic hub with Atlas brass insert.

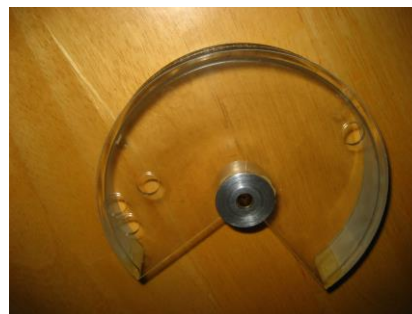
Repaired hub showing flat washer that was installed. This particular drum has no cracks.

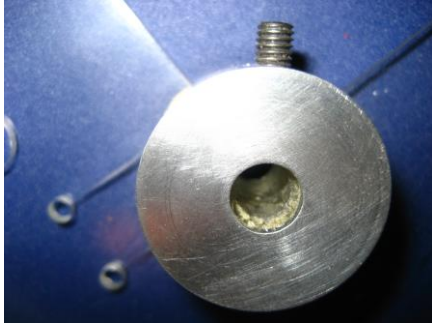
Bottom side of repaired hub

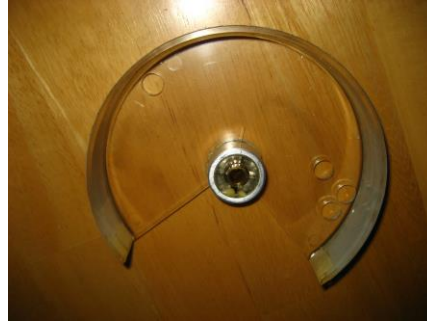
View of repaired hub that has stress cracks

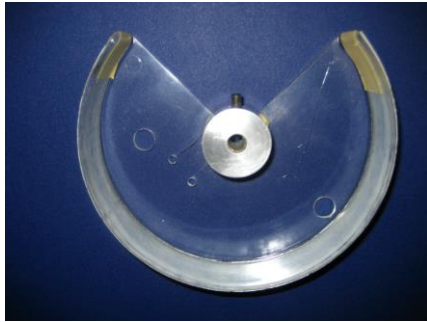
View of repaired hub with repaired stress cracks.

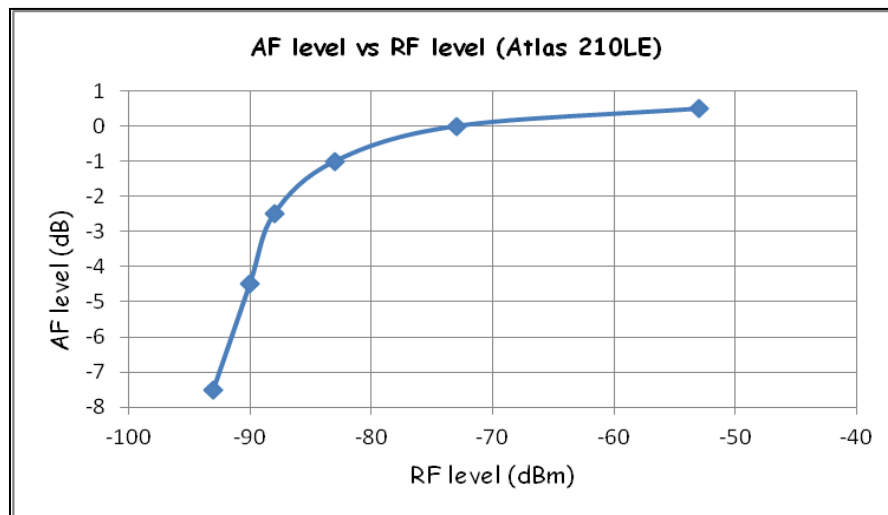
The signal is set to the most sensitive band, which in this case is 80M. The XG3 is set to 50uV and the output level noted. The level of the XG3, and attenuators is adjusted until the level falls 3 dB. Measurements will also initially be made at RF intermediate levels to look at the slope (change in AF level vs. RF level). Some AGC systems are very flat, while others like the Elecraft K2 has a noticeable slope.

The AGC threshold (-3dB) appears to be around -89 dbm which is quite high. The level is about 8 uv. The level quoted by the manufacturer is 5 uv or -93 dbm, so this is about 4 dB different. Although I have made changes to the demodulator circuit (discrete diode mixer), this isn't expected to change the threshold)

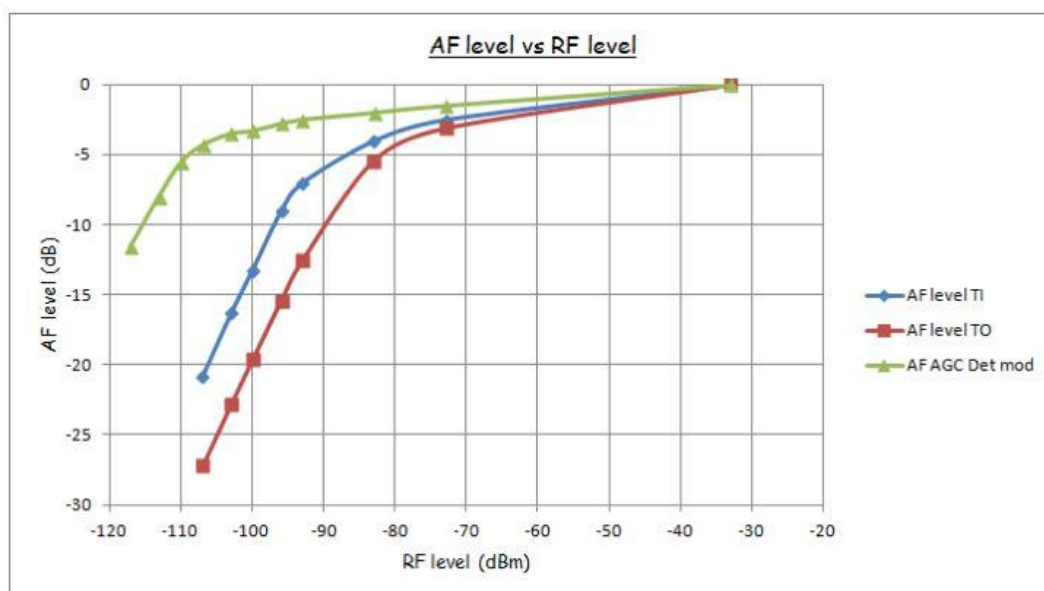
On PC300 card, change C320 to 47uF (from 15uF), change R315 to 1k5 (from 1k) and change R314 to 1k (from 3k3). Add a 5v1 Zener across R312, stripe to the chip.

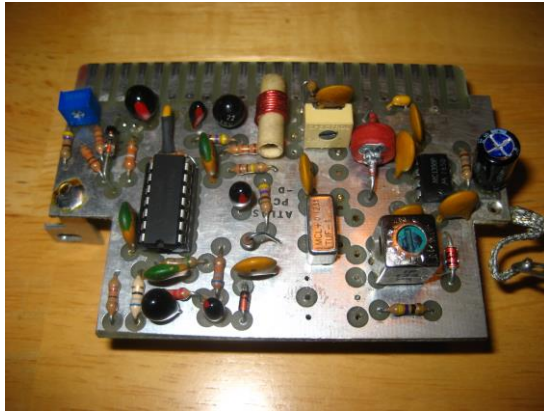
Top side of PC-200 board with TUF-1 Mixer installed. Note space that was freed up by removing the original mixer toroid coils and diodes. The blue and yellow pots have been added per previous discussion.

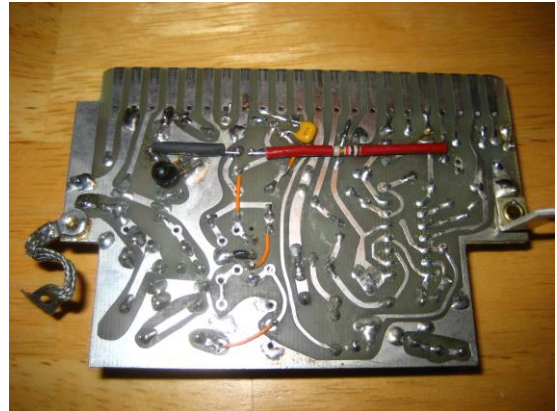
Bottom side of PC-200 board with the TUF-1 jumpers installed. Note orange 2200 pf capacitor installed at bottom of the board to replace the original green Mylar capacitor.

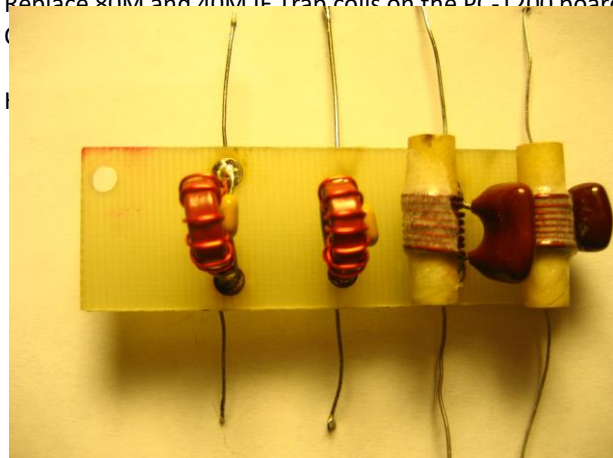
This is a reworked filter board from an early 210 radio. The middle IF trap is factory installed with the 2200 pf polyester film capacitor and the tunable coil.
